SERVICE INFORMATION

Bulletin Nbr: 811-2091

Rattling from inside the first bow and latch handle difficult to operate

Saab 9-3 Convertible up to and including VIN X7024103.

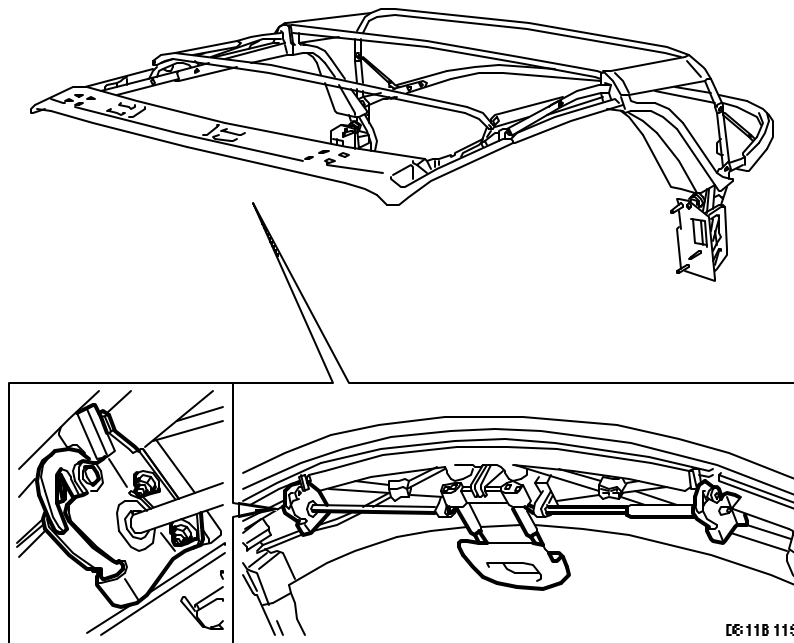
On certain cars, it is possible that a rattling noise can be heard from inside the first bow. The sound can be traced to the first bow latch and latch handle.
