SERVICE INFORMATION

Bulletin Nbr: 870-2020

Problems adjusting heating

Cars affected

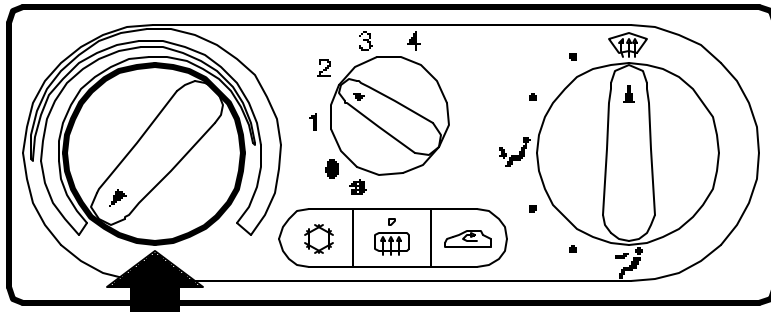
D870B601

The heater temperature control cable on certain cars within the above VIN intervals could be bent or broken. This may be caused by a stiff air blending flap (heater shutter), insufficient clearance between the cable loop at the end of the cable and the pin on the lever, low safety margin (materials too close in tolerance) or a restriction in the cable sheath.

50 45 752 Adjuster cable (CA: 306577263)
