## Subject: ABS Electronic Control Module

Application: 1991 9000

CATEGORY	
<b>Brakes</b>	
SECTION <b>5</b>	PAGE <b>7</b>
ISSUE <b>11/93-0408</b>	CODE <b>590</b>

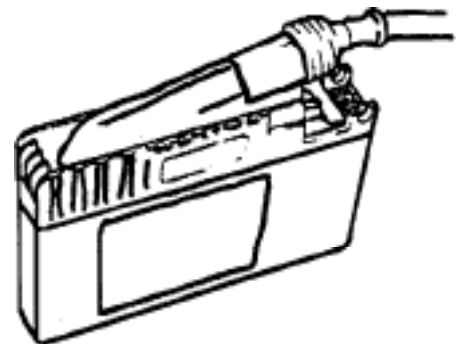
**Figure 1.** ABS Electronic Control Module (ECM)

Certain 1991 9000 models may experience water seeping into the wiring for the ABS electronic control module (ECM). The water can run along the wiring and collect in the ECM connector where it can cause corrosion of the connecting pins. Should this happen, the ANTI LOCK warning lamp may illuminate and different diagnostic trouble codes may be stored in the ECM.

1. Remove the ABS ECM and its connector. See Figure 1. Inspect the pins on the ECM for signs of corrosion.

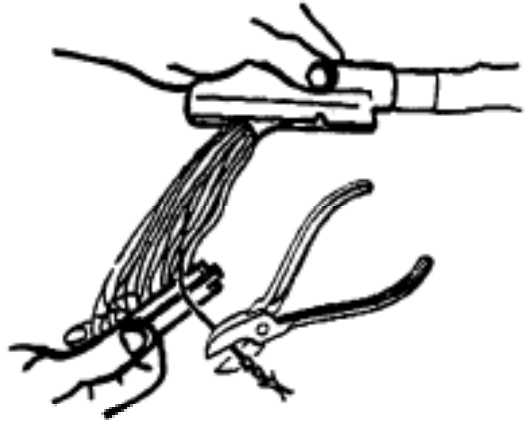
**Figure 6.** Removing corroded connecting pins

5. Inspect the connector pins. If severe corrosion is evident, the pins must be replaced.

Use a terminal repair tool (from Kit P/N 85 80 110) and remove the corroded connecting pins and cut them off from their leads. Make sure that these leads are not also corroded. If they are, cut them shorter until no corrosion is evident. See Figure 8.
