Subject: Coolant Leakage At Water Pump

Application: 9000 with 2.0L Engine

CATEGORY	
Engine	
SECTION 2	PAGE 33
ISSUE 06/93-0343	CODE 262

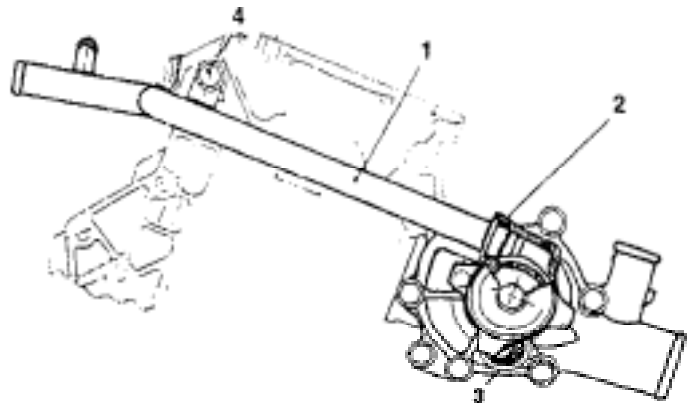
Figure 1. Areas Indicating Where Water Pump May Leak

When attempting to diagnose a water pump leak, it is extremely important to determine where the coolant is leaking before performing any corrective action and/or replacing the pump unnecessarily.

In addition to hose connections, leakage may occur:

- l at the shaft seal. This will result in coolant being evident around the weep hole. See Figure 1-3.
- l at the connections between the by-pass pipe (see Figure 1-1) and the water pump (see Figure 1-2).

A. If leakage can be traced to the shaft seal and this results in low coolant level in the expansion tank, then the water pump should be replaced. Order Kit P/N 93 21 670.

B. If leakage is found at the connection between the by-pass pipe (see Figure 1-1), and the water pump (see Figure 1-2), then thoroughly clean the area around these parts:

1. Drain coolant.
2. Remove the water pump.
3. Loosen the bolt (see Figure 1-4) for the by-pass pipe.
4. Thoroughly clean the mating surfaces on the by-pass pipe and water pump.
5. Fit a new O-ring on the by-pass pipe. Order P/N 79 72 696.
6. Insert the by-pass pipe into the water pump and refit the pump using a new gasket.
7. Press the by-pass pipe firmly into the water pump and tighten the bolt (see Figure 1-4).
 - a. Refill with coolant.
9. Start the engine, let it run up to temperature and verify that there is no more leakage.
