# Subject: New Ignition Relay

Application: Certain 1993 900 Models

CATEGORY		Electrical	
SECTION	3	PAGE	73
ISSUE	06/94-0472	CODE	365

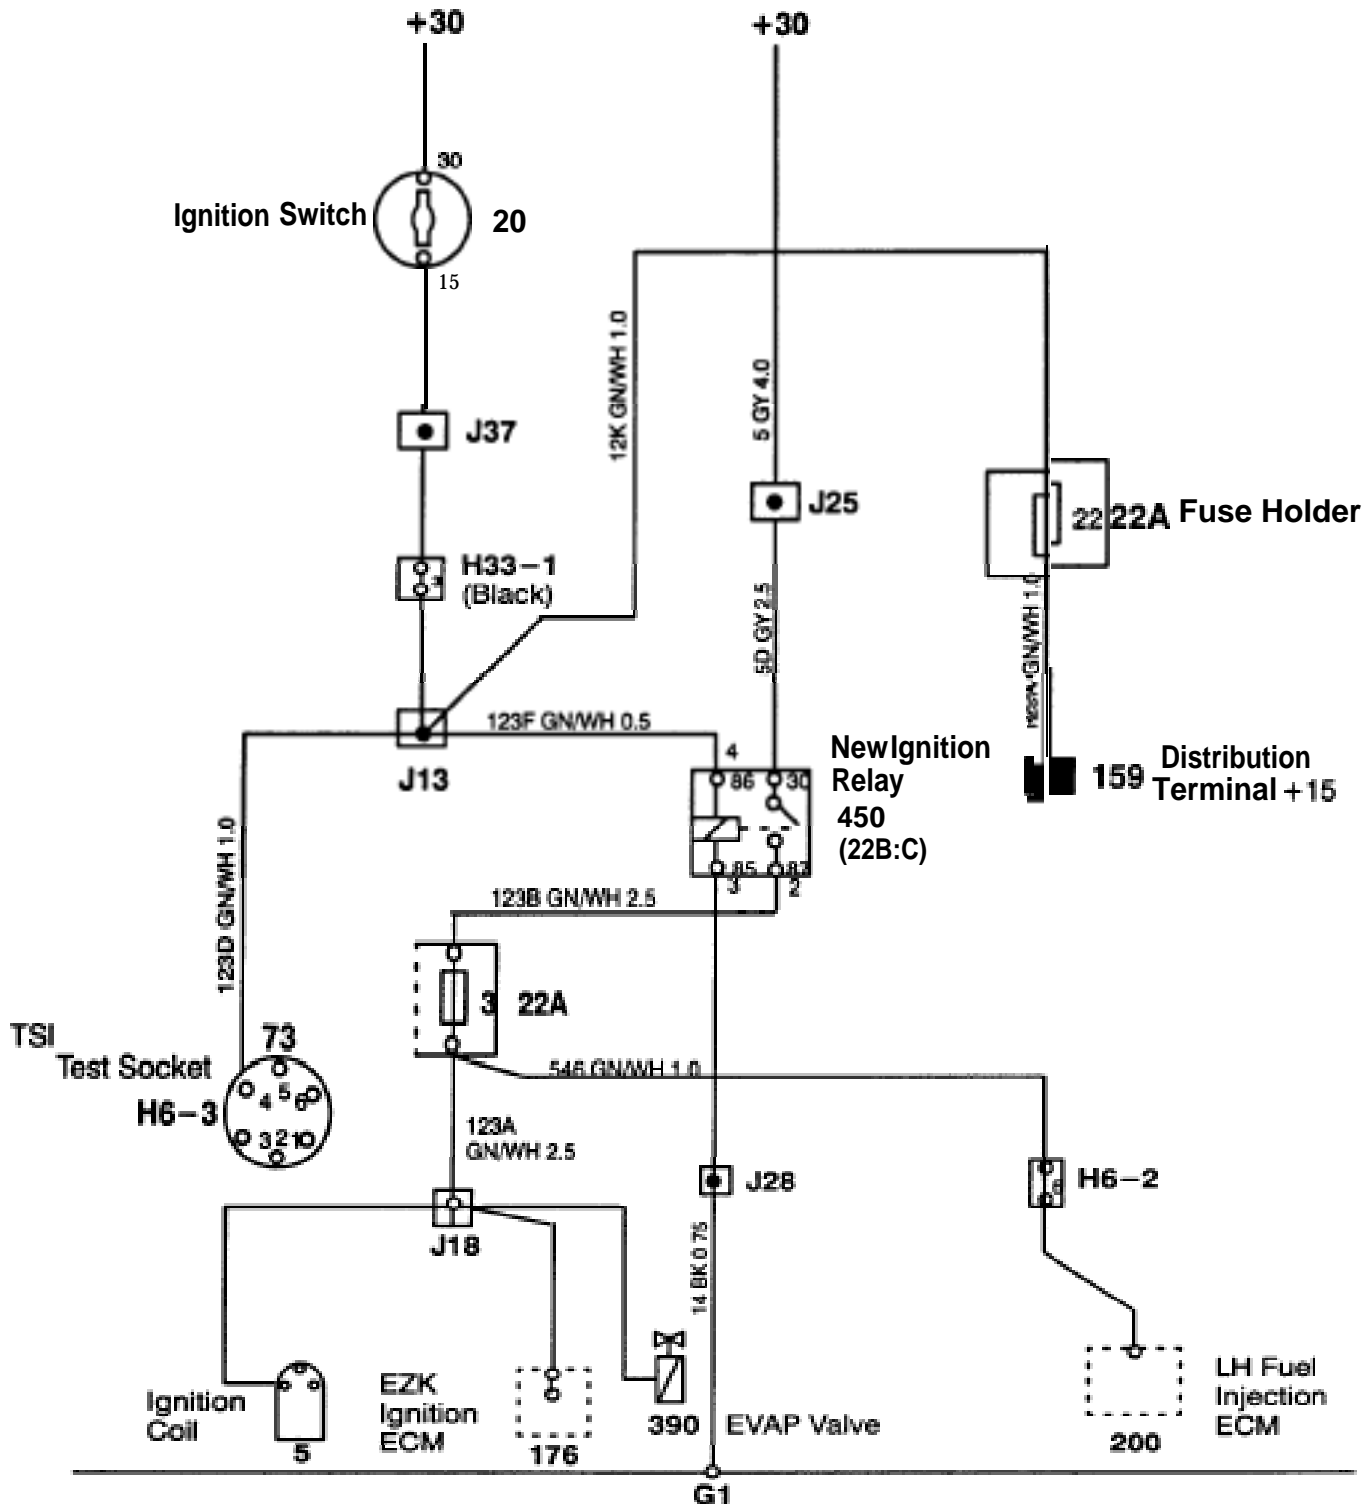
As of the ~~VIN~~ Serial Numbers listed below, a new ignition relay was introduced into production which improves the starting performance on 900 models. It does so by reducing the voltage drop in the ignition system during starting.

This new **relay**, fitted in position C of the main fuse box, cannot be found on existing wiring diagrams. Please see page two of this bulletin for an updated diagram. You might want to make copies of the wiring diagram to paste into your dealership's copies of Section ~~3-2~~ Electrical system, system diagrams, operation and fault tracing MI 991-92 Service Manual, P/N 03 44 028.

NOTE: Relay 450 can be added to position C of the relay panel on 1990 and later 900's but note that wire colors, numbers, etc. will vary. The object is to feed direct battery voltage to the ignition system and avoid any voltage drop that may be present in the existing wiring. The ~~GNWH~~ wire is used to control the relay.

NOTE: Remove ~~GNWH~~ 1.0 wire number 546 from the +15 distribution terminal in the main fuse box and connect it to the fused side of fuse #3. This moves the +30 input for the LH ECM 200 from fuse #22 to fuse #3.
