Parts & Service Information

Subject: Service Campaign to Inspect Poly-Vee Belt Tensioner Mount

Application: Certain 1990 9000's with B234 Engine

CATEGORY	
Engine	
SECTION 2	PAGE 1
ISSUE 06/90-0007	CODE 216

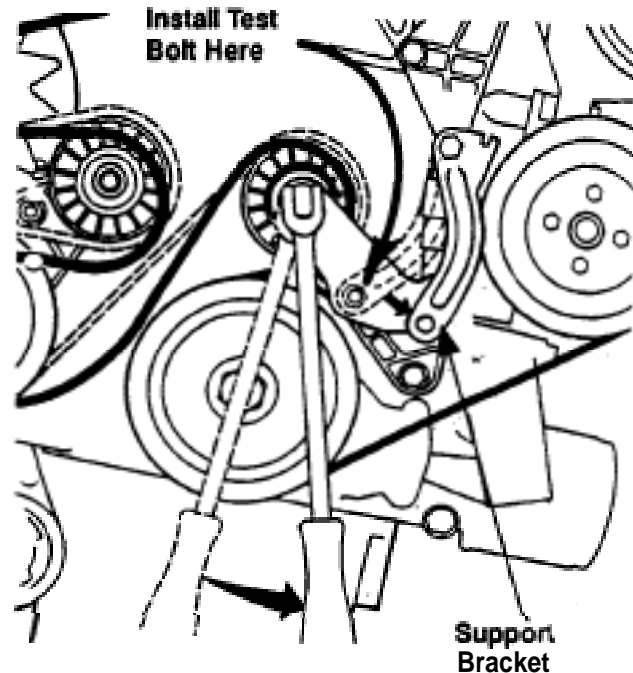
Figure 1.

Saab has discovered a production batch of poly-vee belt tensioner mounts that may have been mismanufactured. The tensioner assembly mounts on a spindle which may have a press fit that is out of specification. The spindle could then work out of its mounting plate, allowing the belt tensioner to loosen. About 30% of the affected vehicles will require corrective action.

1. Lift up the car and remove the right front wheel.
2. Remove the inner fender liner.
3. Apply constant pressure on the tensioner pulley (left-hand threaded bolt) in order to compress the tensioner enough to remove the poly-vee belt from the left-hand idler pulley (Figure 1).
4. Remove the bolt that secures the lower end of the tensioner support bracket and move the bracket out of the way (Figure 1).
5. Install a special test bolt, P/N 79 77 382, in place of the bolt removed to release the support bracket. This is a Class 10.9 (Grade 8) bolt which will provide a more accurate torque reading for testing the spindle in the next step. **Do not use the original bolt removed from the tensioner support bracket.**

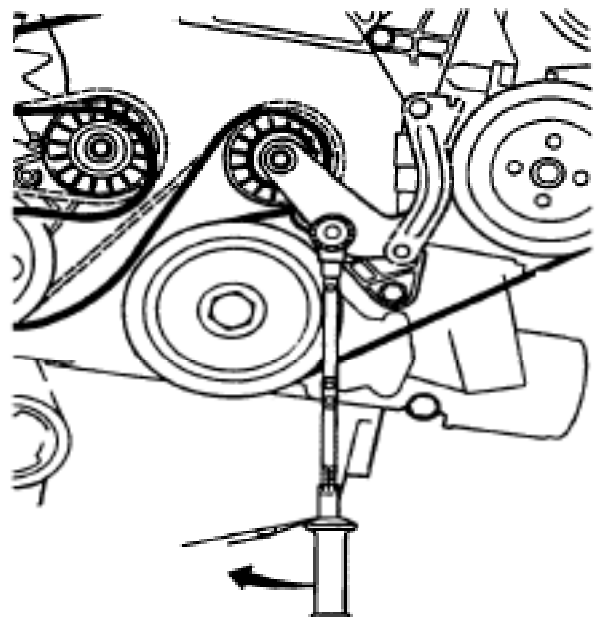
If a torque of 32 Nm cannot be reached (the bolt continues to rotate) then the spindle is faulty and the mounting plate must be replaced.

6. With a torque wrench set at 32 Nm (24 ft lbs), tighten the bolt until the wrench clicks (Figure 2). If this torque specification can be reached, the mounting plate does not require replacement. Remove the bolt used in the test and proceed to step 12.
