**Service Information**

**SUBJECT: CORRECTING DRIVEABILITY COMPLAINTS DUE TO EXCESSIVE LINE PRESSURE**

**ISSUE: 06/89-1151**

**APPLICATION: ALL 9000 MODELS, 1988- 900 MODELS**

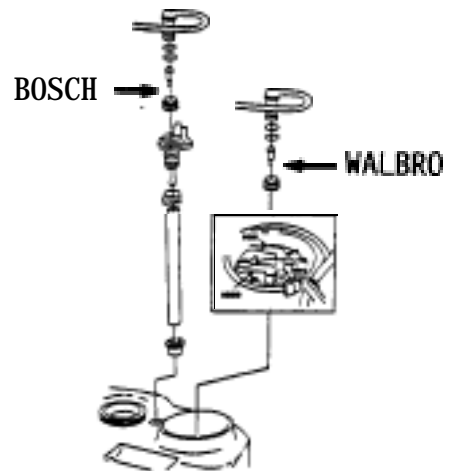
On vehicles with the fuel return line check valve integrated into the fuel line at the tank (Figure 1), it is possible for the rubber flap that acts as the check valve to become detached and block the return line or the ejector pump. A blocked or restricted fuel return line will cause driveability complaints due to excessive line pressure. This complaint can be diagnosed by measuring the fuel system pressure with a pressure gauge or the LH Tester. To prevent this, a revised check valve has been introduced into early-M89 production. The redesigned check valve consists of a new lower housing to the return line fitting and a valve core insert (Figure 2). This check valve may also be used to correct earlier cars.

**Figure 1.** The return fuel line check valve located at the fuel tank.

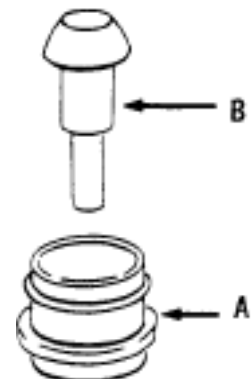
**Figure 2.** The new check valve consists of a lower housing (A) and a valve core insert (B).

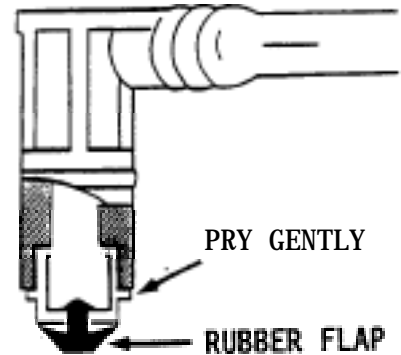
3. If the rubber flap is missing from the old-design check valve (Figure 4), it will be necessary to follow one of the steps (4A or 4B) listed below to remove any remnants of the flap.

Figure 4. Old-design check valve with rubber flap.

4. Remove the existing lower valve housing by prying gently at the joint with a screwdriver (Figure 4).

A) On cars with Walbro pumps, see the ejector cleaning procedure in the 900 Service Manual Section 0, "News" for 1989, p. 36-37. (For Warranty repairs, add labor operation for "R & R Walbro Feed Pump").

B) On cars with Bosch pumps, remove the fuel tank fitting for the return line and clean it with compressed air. Inspect and replace the return line grommet if necessary.

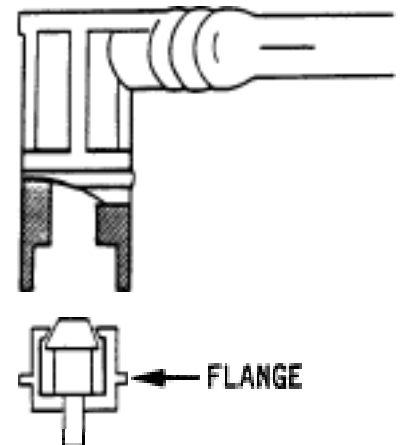
Figure 5. Install the valve core insert into the housing. Install the check valve assembly into the return line fitting.

5. Insert the new check valve insert into the new check valve housing. Install this check valve assembly into the return line housing. (Figure 5). The collar of the new housing should engage the groove in the return line fitting when the flange is flush against the bottom of the fitting (Figure 5).

6. Fit new O-rings (P/N 93 84 280) on the return line fitting.
7. Re-install the return line fitting into the fuel tank (Bosch pump) or the fuel pump (Walbro pump).
