Subject: Front Wheel Bearing Noise

Application: 900 Models, 1981-

CATEGORY	
Suspension	
SECTION	PAGE
7	3
ISSUE	CODE
03/91-0099	774

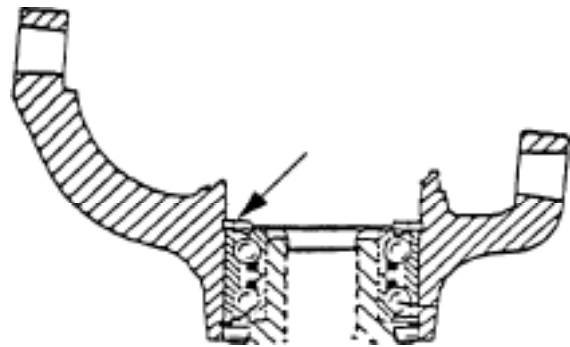
Figure 1. Thoroughly clean the surfaces of the snap ring, snap ring groove in the steering knuckle and the bearing.

2. Remove the inner snap ring. Thoroughly clean the surfaces of the snap ring, snap ring groove in the steering knuckle and the bearing (Figure 1).

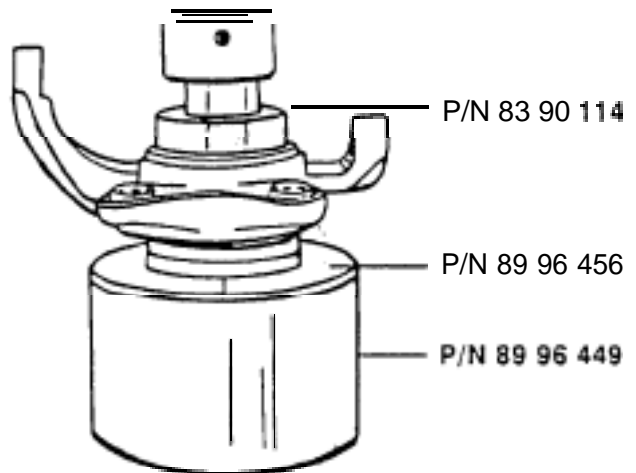
Figure 2. Place the steering knuckle on a press and press the bearing into contact with the outer snap ring.

3. Place the steering knuckle on a press and using the tools shown in Figure 2, press the bearing into contact with the outer snap ring.

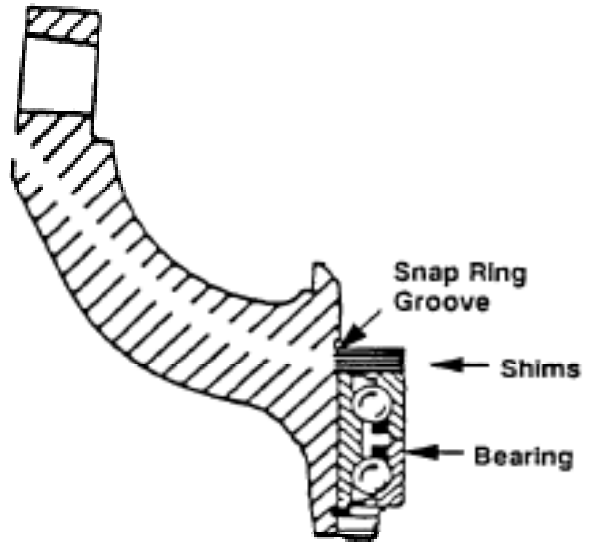
Figure 3. Place enough shims (see table) on the bearing to eliminate the space between the bearing surface and the snap ring groove.

- Place enough shims (see table) on the bearing to eliminate the space between the bearing surface and the snap ring groove (Figure 3).

- Lubricate the shims with oil to prevent corrosion.
- Refit the inner snap ring, ensuring that it snaps properly into place in the groove.
- Reinstall the steering knuckle housing.
- Test drive the car to ensure that it is running properly.
- Check that the clunking noise has been eliminated by driving slowly forward and backwards under full steering lock.
