SERVICE INFORMATION

Number: 367-1713
Year: 1997
Month: FEBRUARY
Market: US

Radio interference on AM

Saab 900 M94-. For detailed information, see the relevant type of interference in point C.

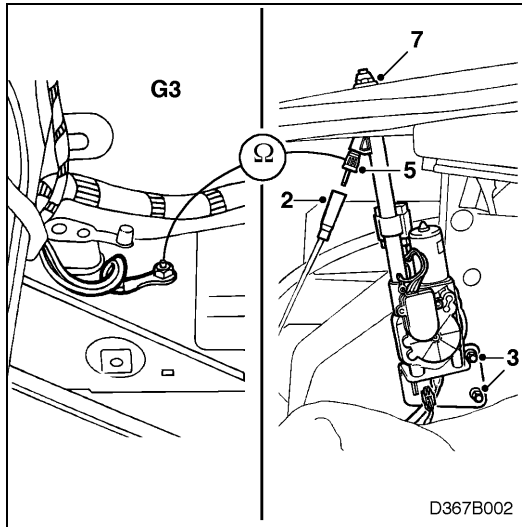
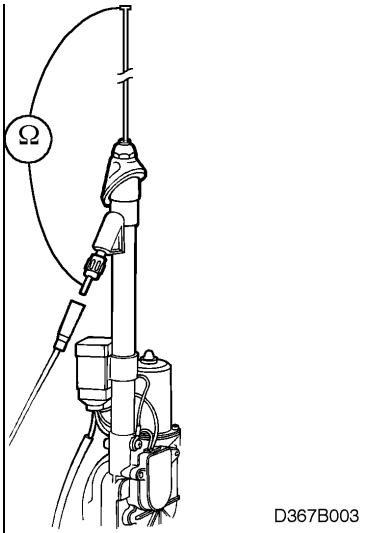
A. Antenna's ground connection unsatisfactory.

It is extremely important for the antenna to be properly grounded. This can be checked as described below.

- 3 Undo the two nuts securing the antenna.
- 4 Place a piece of insulating paper between the antenna bracket and the car body.
- 5 Take a resistance reading across the antenna connector's screened plug and grounding point G3 below the left-hand rear light cluster.
- 6 If the reading obtained is less than 10 ohms the ground connection is OK. Remove the paper and continue with point B.
- 7 If the reading is above 10 ohms, adjust the lock washer until it is in good contact with the body metal.
- 8 If the resistance reading obtained is less than 10 ohms after adjusting the washer, remove the paper and continue with point B.
- 9 If it is greater than 10 ohms there may be an open circuit in the antenna. Change the antenna/aerial and continue with point C.

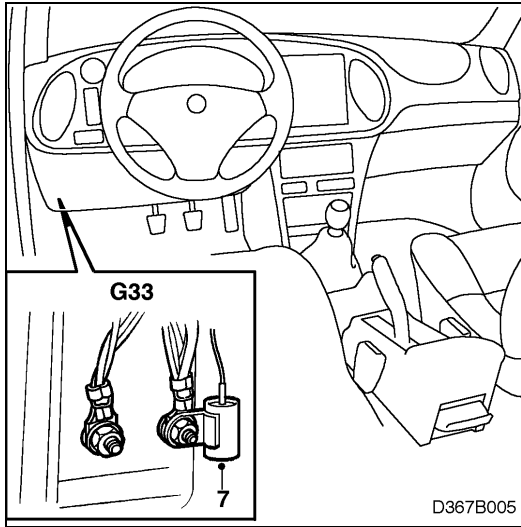
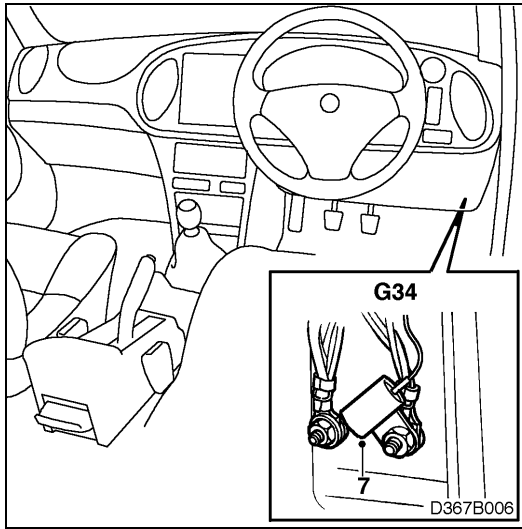
C1. Background noise

On M94 cars and up to and including M96 cars, the ICE may be the cause of background noise. Starting with M97 cars an interference suppressor has been introduced in the ICE.

Remove fuse 35. This should result in a noticeable reduction of the noise.

Fit interference suppression kit 48 72 677 (CA=30567465) as described below.

- 1 Remove the dashboard's main fuse board.
- 2 Remove the lower section of the dashboard on the driver's side.
- 3 Remove fuse 35 and extract the blue/black lead from the fuse holder.
- 4 Cut the connector off the lead.
- 5 Cut the interference suppression capacitor's lead to a length of 100 mm.
- 6 Twist it together with the blue/black lead in a new connector and plug the connector into fuse holder 35.

- 7 LHD: fit the interference suppression capacitor on the right-hand grounding screw at grounding point G33.
RHD: fit the interference suppression capacitor on the right-hand grounding screw at grounding point G34.

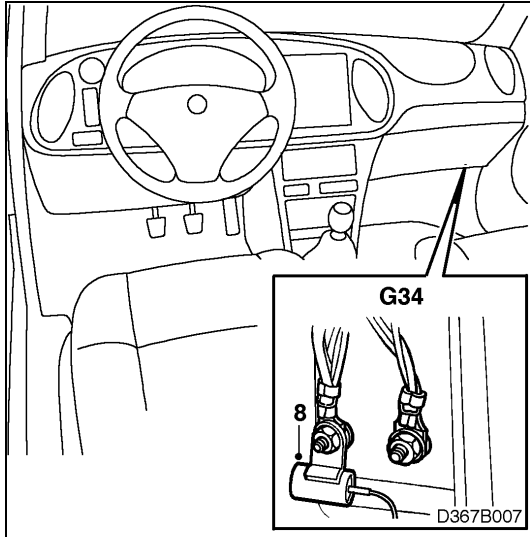
C2.2 Trionic

The fault occurs on cars equipped with Trionic M94-.

Check whether the tone comes from the PWM control of the idle air control valve, as follows:

- 1 Start the engine and switch on the radio.
- 2 Unplug the connector from the idle air control valve in the engine bay. The tone should now disappear.

The fault can be rectified by fitting interference suppression kit 48 72 685 (CA=30567466) as described below:

- 1 Remove the Trionic control module as described in group 2 "Trionic".
- 2 Unplug the connector and extract the socket at position 49 (red/blue lead).
- 3 Cut off the connector.
- 4 Cut all but 200 mm off the interference suppression capacitor's lead.
- 5 Twist the red/blue lead together with the interference suppression capacitor's lead in a new connector.
- 6 Refit the socket in position 49 of the connector.
- 7 Plug in the connector.
- 8 Mount the capacitor on the left-hand screw at grounding point G34.
- 9 Check the result of the above measures by starting the car and switching on the radio.

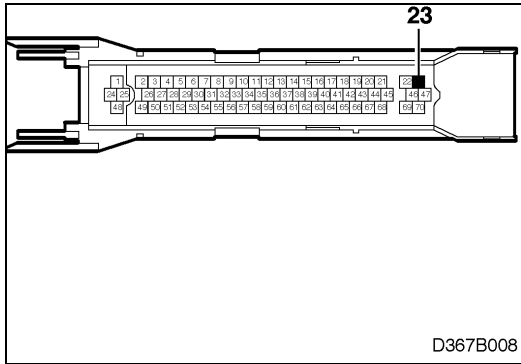
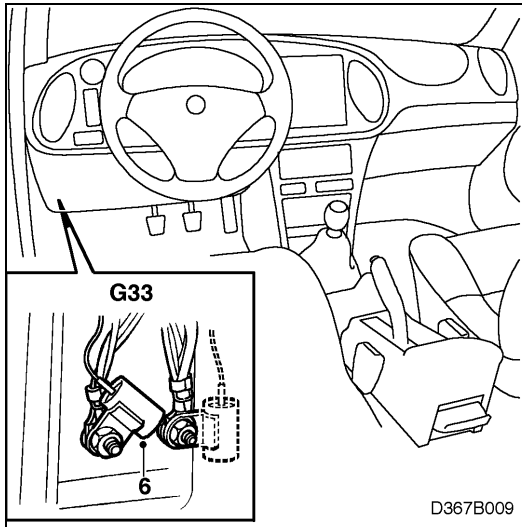
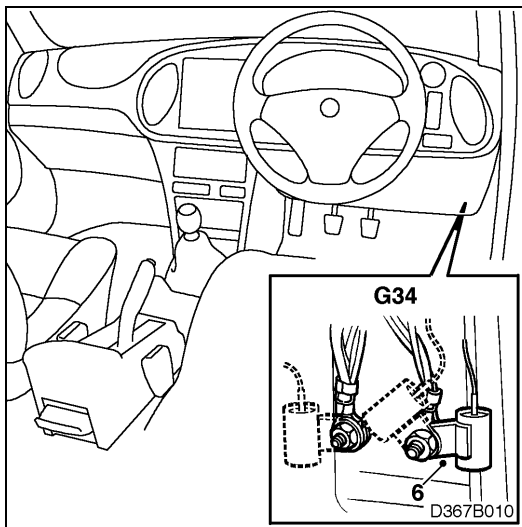
C2.3. ICE

The fault is due to the ICE and occurs on M94- cars.

Check whether the tone comes from the PWM control of interior lighting dimming when the door is closed.

- 1 Switch on the radio.
- 2 Open a door and close it again. A tone is heard while dimming of the interior lighting takes place.

The fault can be rectified by fitting interference suppression kit 48 72 677 (CA=30567465) as described below:

- 1 Remove the ICE control module as described in group 3 "Electrical system - ICE".
- 2 Unplug the connector and extract the socket at position 23 (grey/green lead).
- 3 Cut off the connector.
- 4 Twist the grey/green lead together with the capacitor's lead in a new connector.
- 5 Refit the contact socket in position 23 and plug in the connector.

- 6 LHD: fit the interference suppression capacitor on the left-hand grounding screw at grounding point G33.

- RHD: fit the interference suppression capacitor on the right-hand grounding screw at grounding point G34.

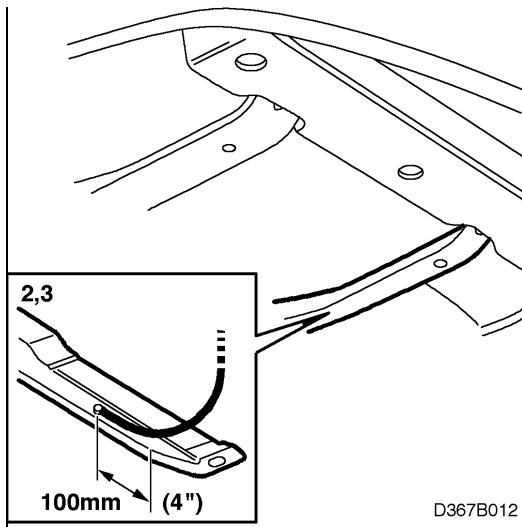
Braid 1, between engine block and cross- member

Ignition system interference can occur on 4-cylinder cars equipped with the Motronic engine management system. The “ticking” sound is heard at its loudest when the engine is idling and diminishes with increasing engine rpm.

The fault can be rectified by fitting interference suppression kit 49 00 015 (CA=30567189) (4 grounding braids) as described below:

- 1 Remove the engine's resonating chamber.
- 2 Fit the grounding braid between left-hand side of the engine block and the cross-member, as shown.
- 3 Secure the braid to the throttle cable by means of a cable tie. The braid should be slack between the engine and the cable tie.
- 4 Refit the resonating chamber.
